Identification of criteria to determine the restoration potential of riparian wetlands in highly degraded agricultural environments

- Final Report

Report produced as part of the project “Identification de critères pour déterminer le potentiel de restauration des milieux humides riverains en milieux agricoles fortement dégradés ” funded by the Fonds National de Conservation des Milieux Humides (FNCMH), Environnement et changements climatiques Canada

April 2019

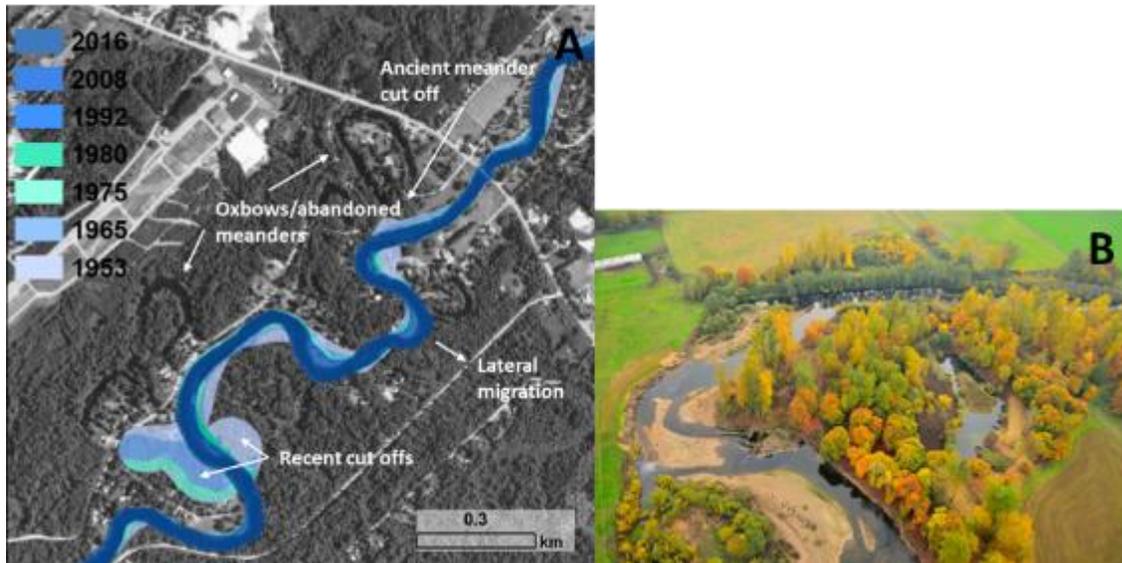
Figure 1: A) Historical analysis of ancient channel positions of the Mastigouche River; B) restored wetlands of the Calapooia River, Oregon (Henderson, 2018).

Riparian wetlands result in part from the physical foundation laid by the dynamics of natural stream processes such as lateral migration and meander cut-offs (Figure 1). Abandoned meanders, known also as oxbows, are rich in biodiversity and constitute riparian wetlands due to the hydraulic connections they maintain with the adjacent watercourse (Phillips, 2013). Riparian wetlands are often priority targets for restoration due to the many ecosystem services they provide that benefit both the environment and society:

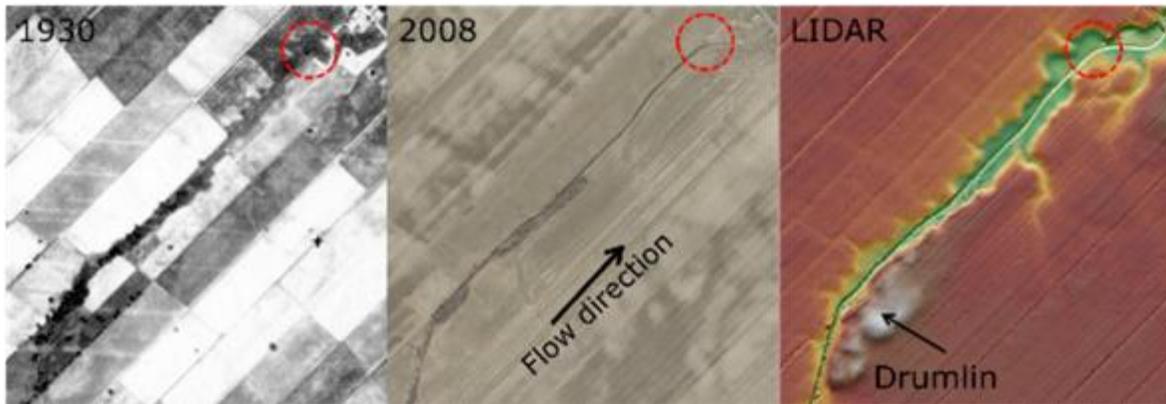
Figure 5 : Historical air photography and LiDAR showing clear indications of ancient meander bends and a drumlin.

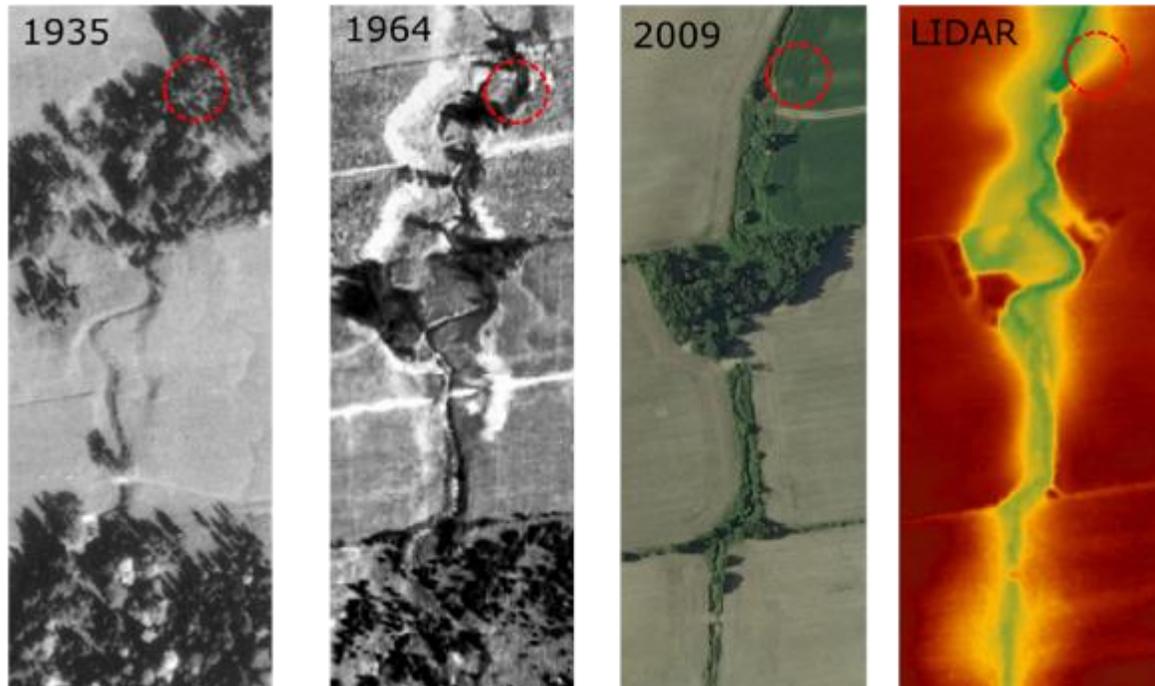
Figure 8 : Historical air photography and LiDAR showing a clear meandering pattern in both 1935 and 1964 while the stream has a straightened pattern in 2009. Gradual deforestation is also observed from 1935 to 2009 and meander scars are visible in the LiDAR. The dashed circle shows the site where groundwater monitoring devices were installed.

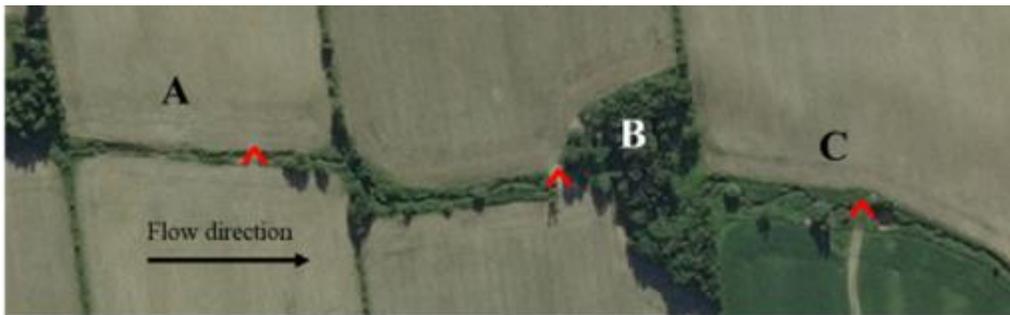
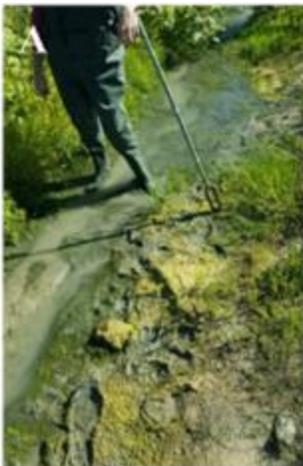
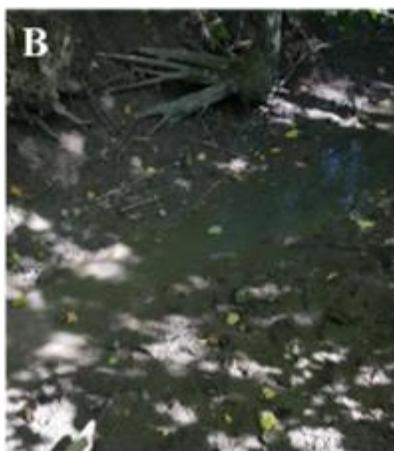
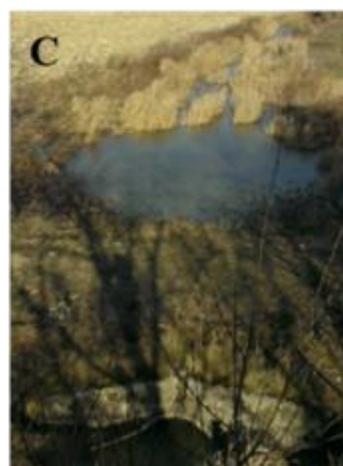
Figure 9 : Study site at PPauB divided into three distinct reaches following a geomorphic assessment conducted in late summer. Reach at low flow A) upstream, reach B) middle, reach C) downstream.

A geomorphic assessment conducted at PPauB during the late summer of 2017 allowed for the identification of three distinct sub-reaches across the study site (Figure 9).

The first reach (Figure 9A) in the upstream section, despite previously being channelized and surrounded by agricultural fields, does show some development of sinuosity as well as variability in depth and flow. Bank slope in this section is relatively mild. Several runs were identified, and pools were typically observed upstream and downstream of most culverts. Clay is the dominant sediment (likely filling material from the adjacent agricultural fields) with a thick layer of siltation in zones of sluggish flow.

The second reach (Figure 9B) consists of a very short section with a forested riparian zone that does not appear to have been channelized post 1964. Some woody debris are present, and the sinuosity is much higher compared to upstream and downstream reaches, explaining the diversity

The third reach (Figure 9C) in the downstream section is lined by agricultural fields on both banks. With the exception of a large pool that has formed downstream of a culvert, the channel pattern is narrow and uniform with very low and slow flow, particularly during late summer. Sediments are dominated by clay and filling material with a layer of siltation in the pool.

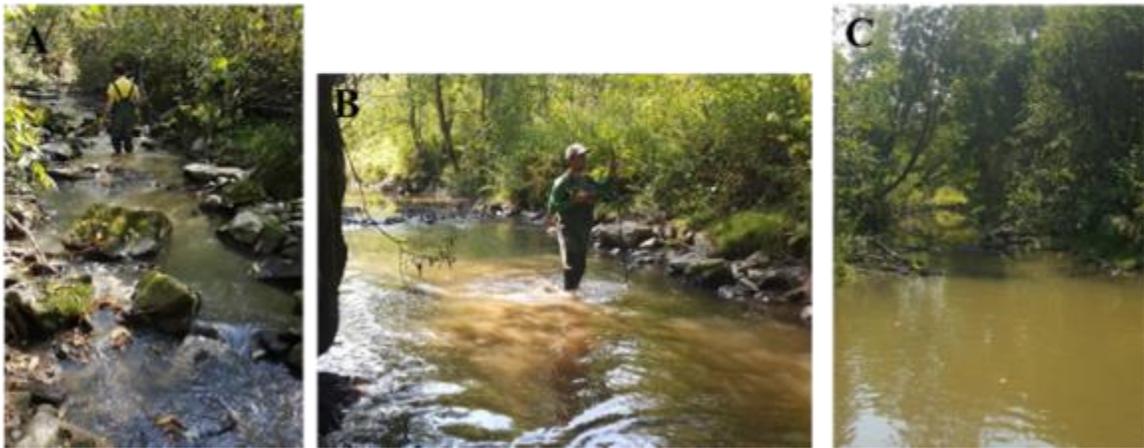
Figure 12 : Study site at RM divided into three distinct reaches following a geomorphic assessment conducted in late summer. Reach A) upstream, reach B) middle, reach C) downstream.

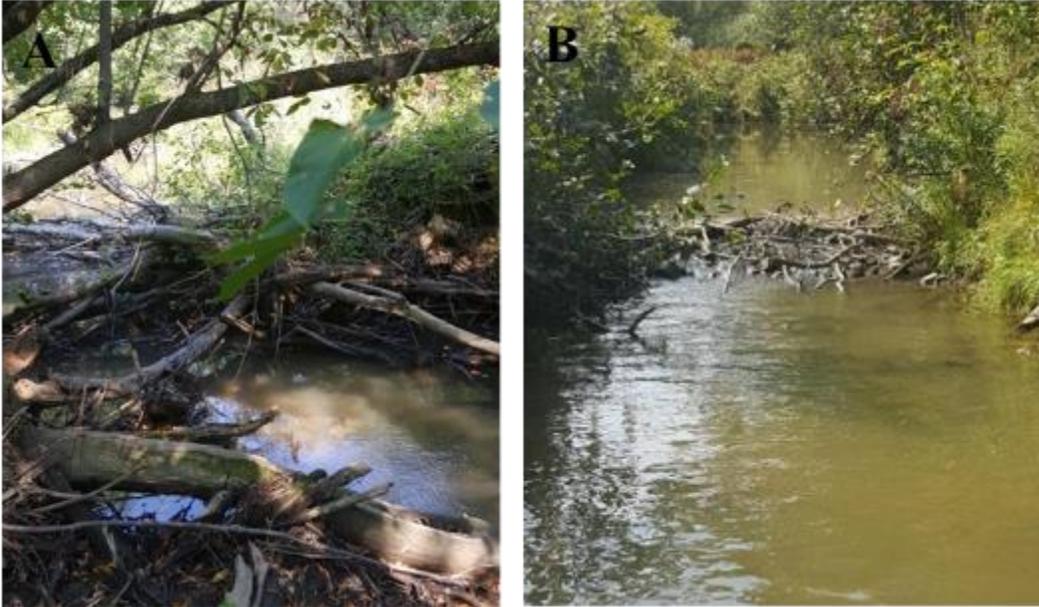
Figure 13 : Examples of woody debris accumulations (beaver dam in some case) at RM A) midstream reach B and B) downstream reach C.

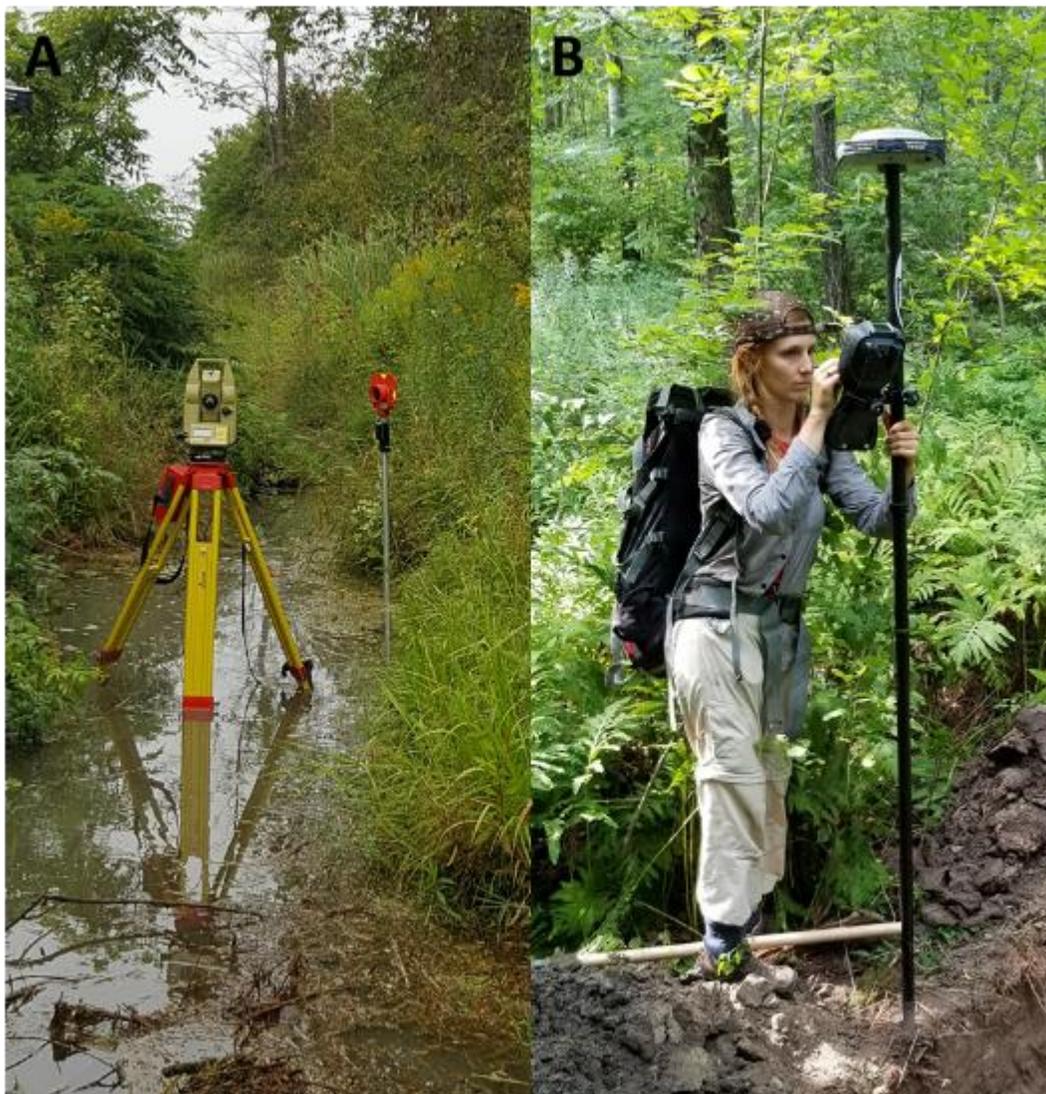
Figure 18: Total station setup at DF A), and dGPS during a survey of RM B).

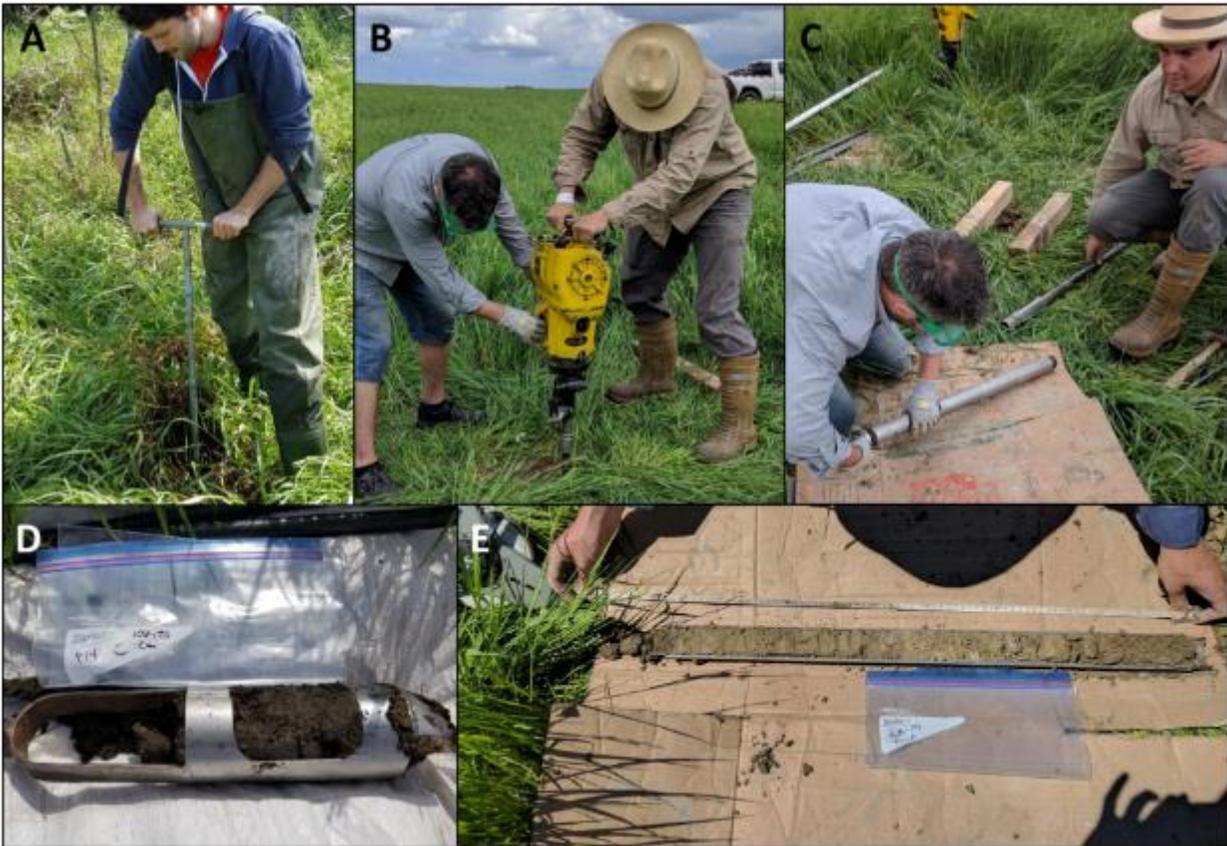
Figure 19: A) Borehole dug at DF using auger; B) borehole dug at PPauB using Pionjar; C) 1m core sample extracted by the Pionjar; D) soil sample extracted with the auger; E) soil sample obtained from Pionjar.

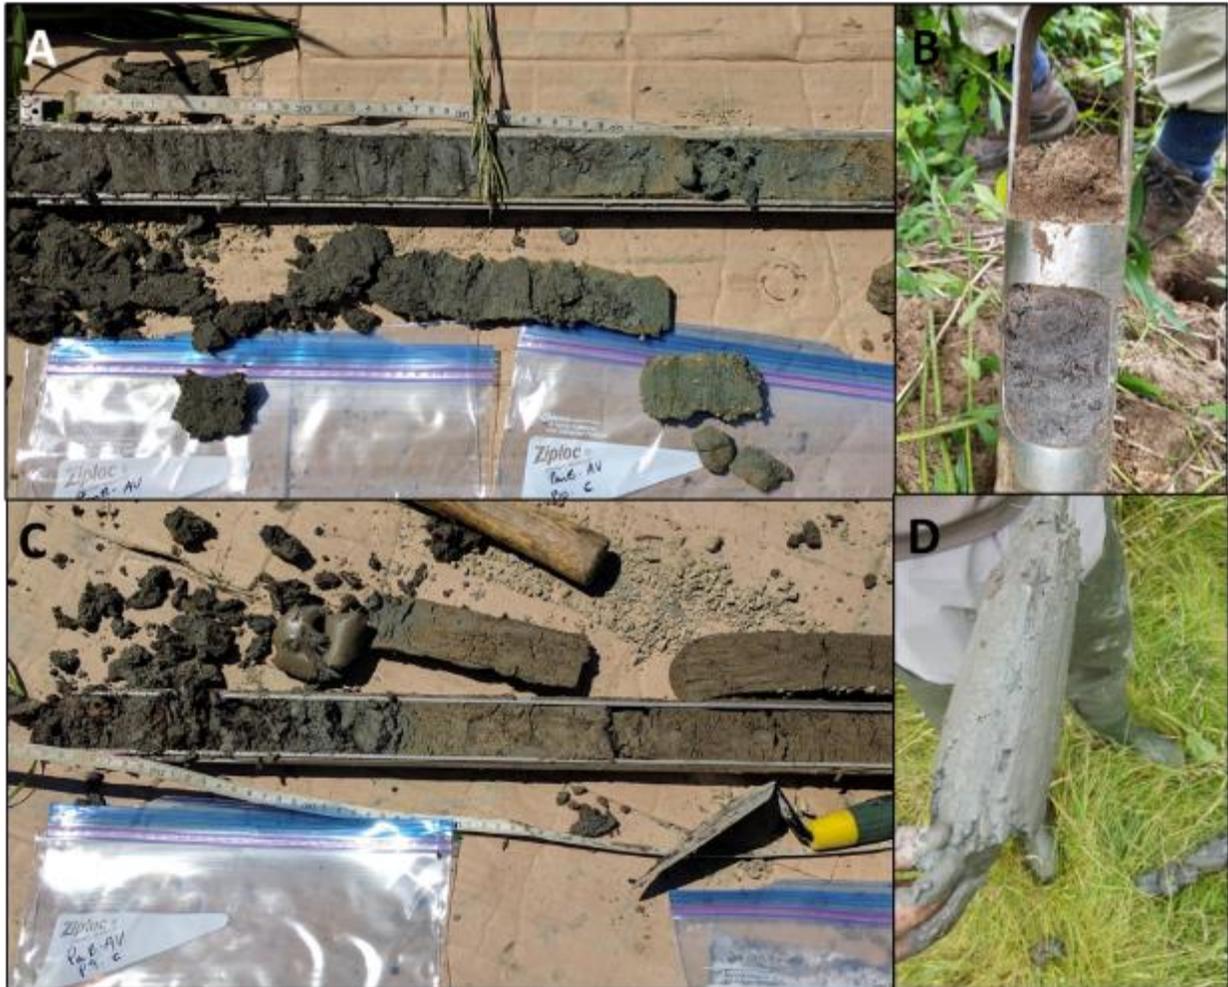
Figure 20: A) example of a transition area between stratigraphic units from a sample extracted at PPauB; clear contact depth between units for a sample extracted at RM B) and PPauB C); D) basal unit of marine clay at DF.

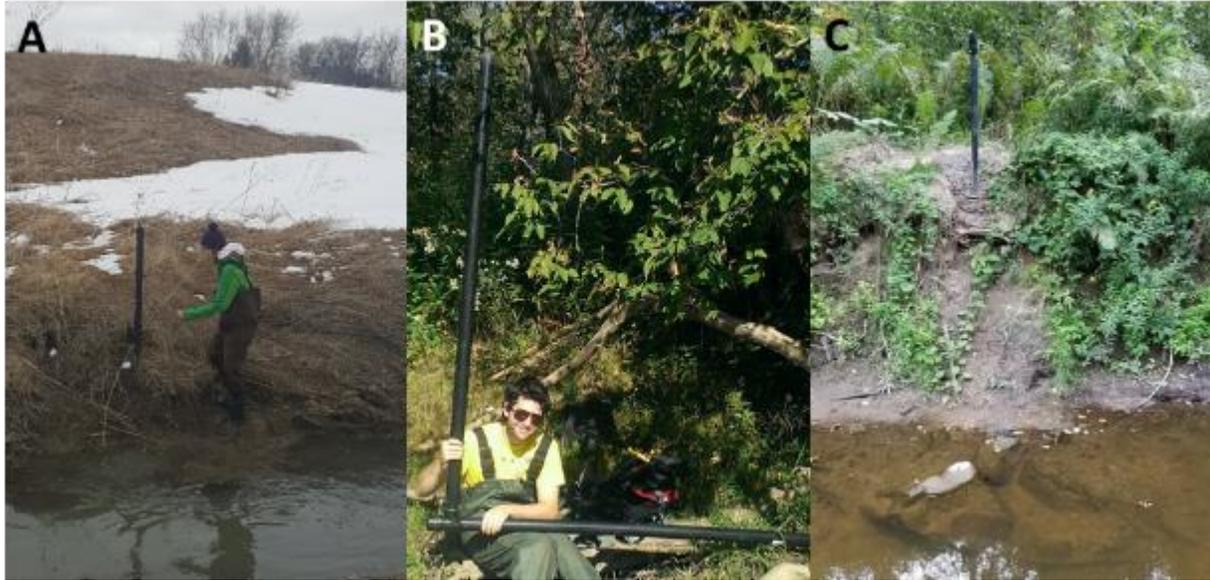
Figure 22: ABS pipes allow for easier access to loggers during readout at DF A), example of L-piping to be installed at RM B), finished installation of L-pipe at RM C).

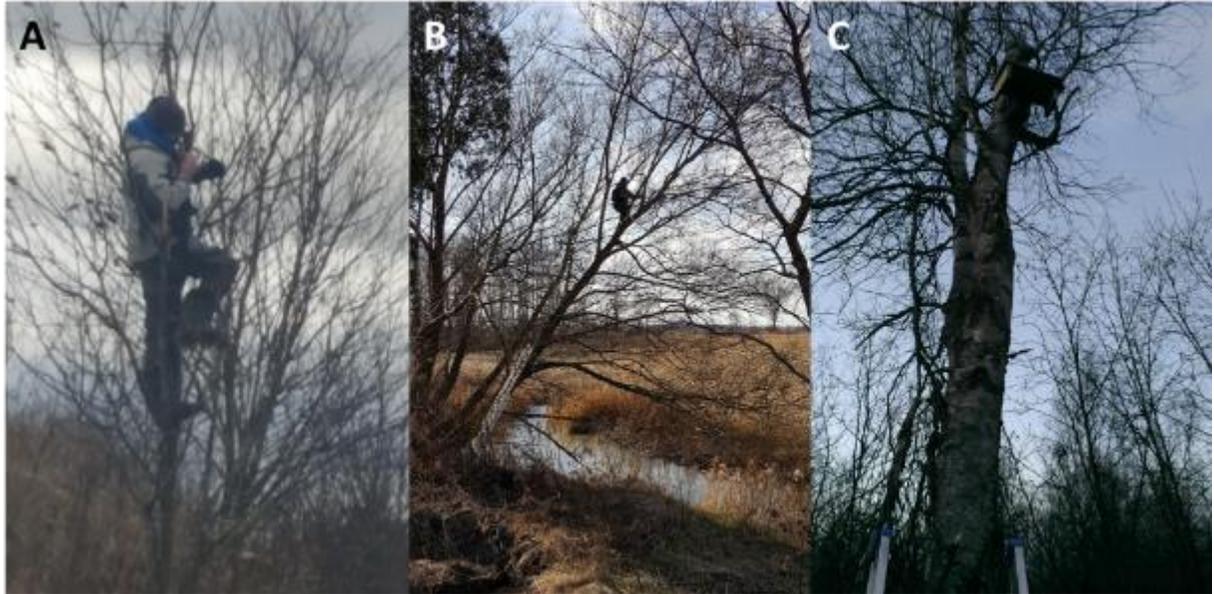
Figure 24: Camera installation at DF A), PPauB B), and RM C).

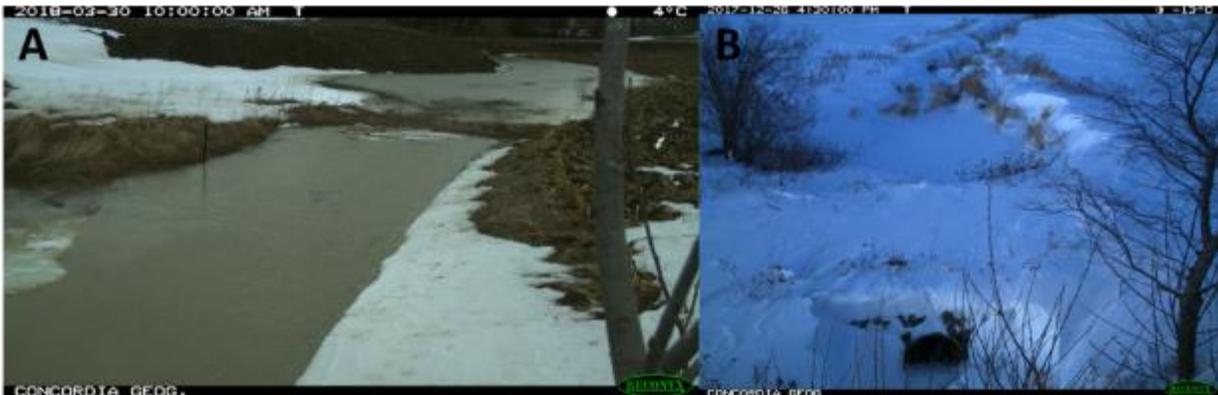
Figure 26: A) Example of overbank flow into ancient meander during early spring flood at DF, B) photos such as this of PPauB in winter allow us to evaluate when snow cover may interfere with pressure transducer readings.

Three cameras (Reconyx hyperfire H500) were installed, one for each site (Figure 24) facing the ancient meander and recording an image every 30 min with a field of view of 42° (Figure 25). The cameras proved very useful for visually documenting flooding events (spring floods) and validating potential surface connections with the ancient meander (Figure 26A). Cameras were also useful for identifying times of snow cover where logger data would not be useable (Figure 26B). Interestingly, even recording once every 30 min, our cameras caught a lot of wildlife (Figure 27A, B).

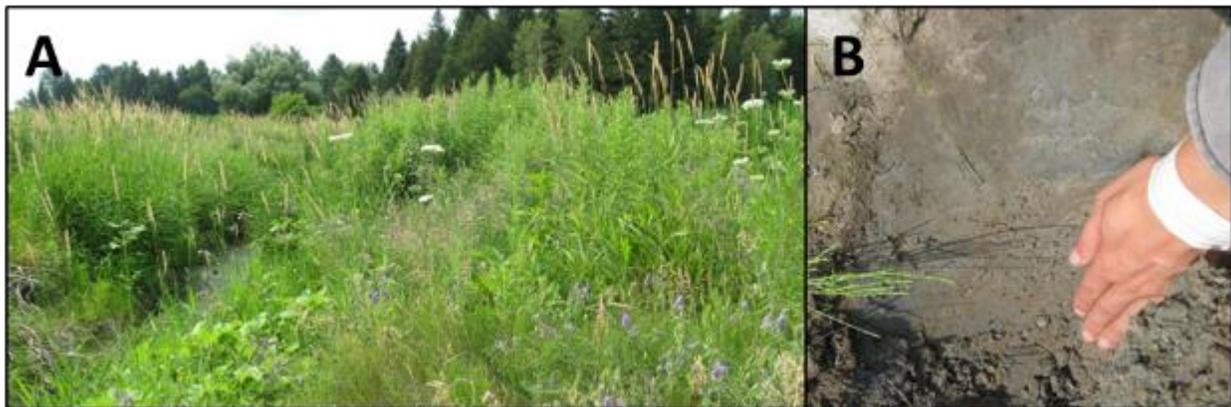
Figure 32: Photo of a homogeneous unit at PPauB A) and a pedon at the same site B) (photo credit: Audréanne Loiselle, 2018).

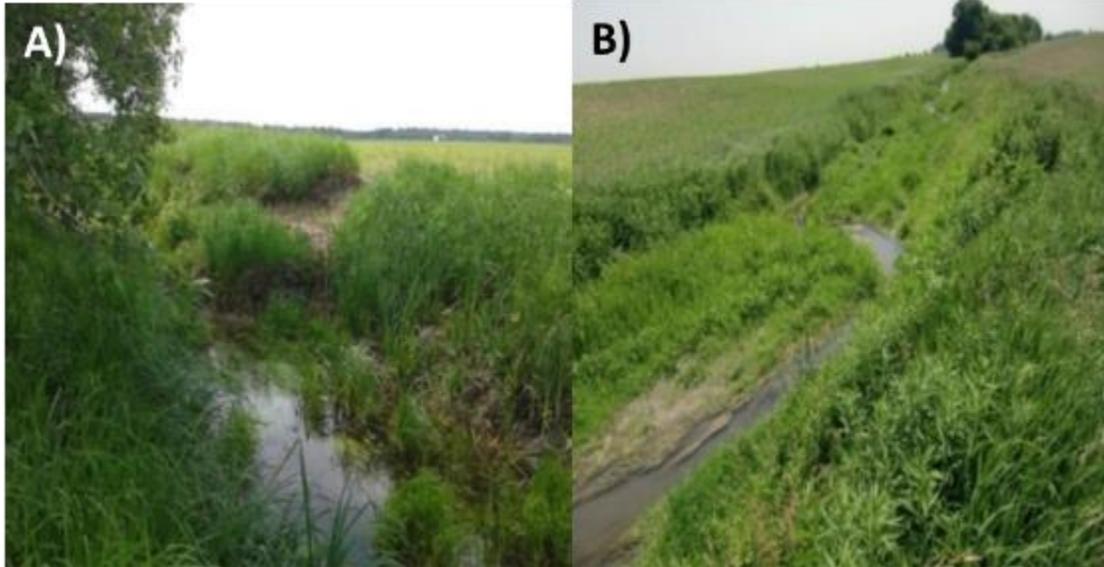
Figure 76: Field examples of erosion (bank failure) A) and deposition (side channel bar) B) for DF (photo: Paradis, 2015).

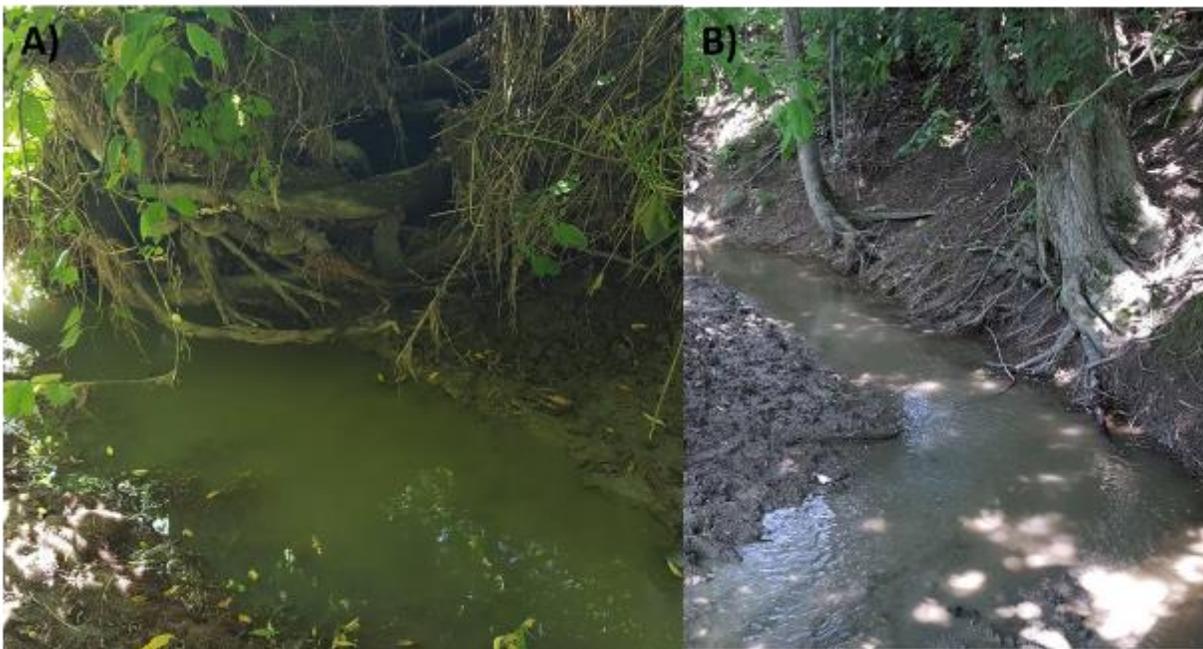
Figure 77: Field examples of bank erosion and deposition for PPauB A) upstream and B) downstream.

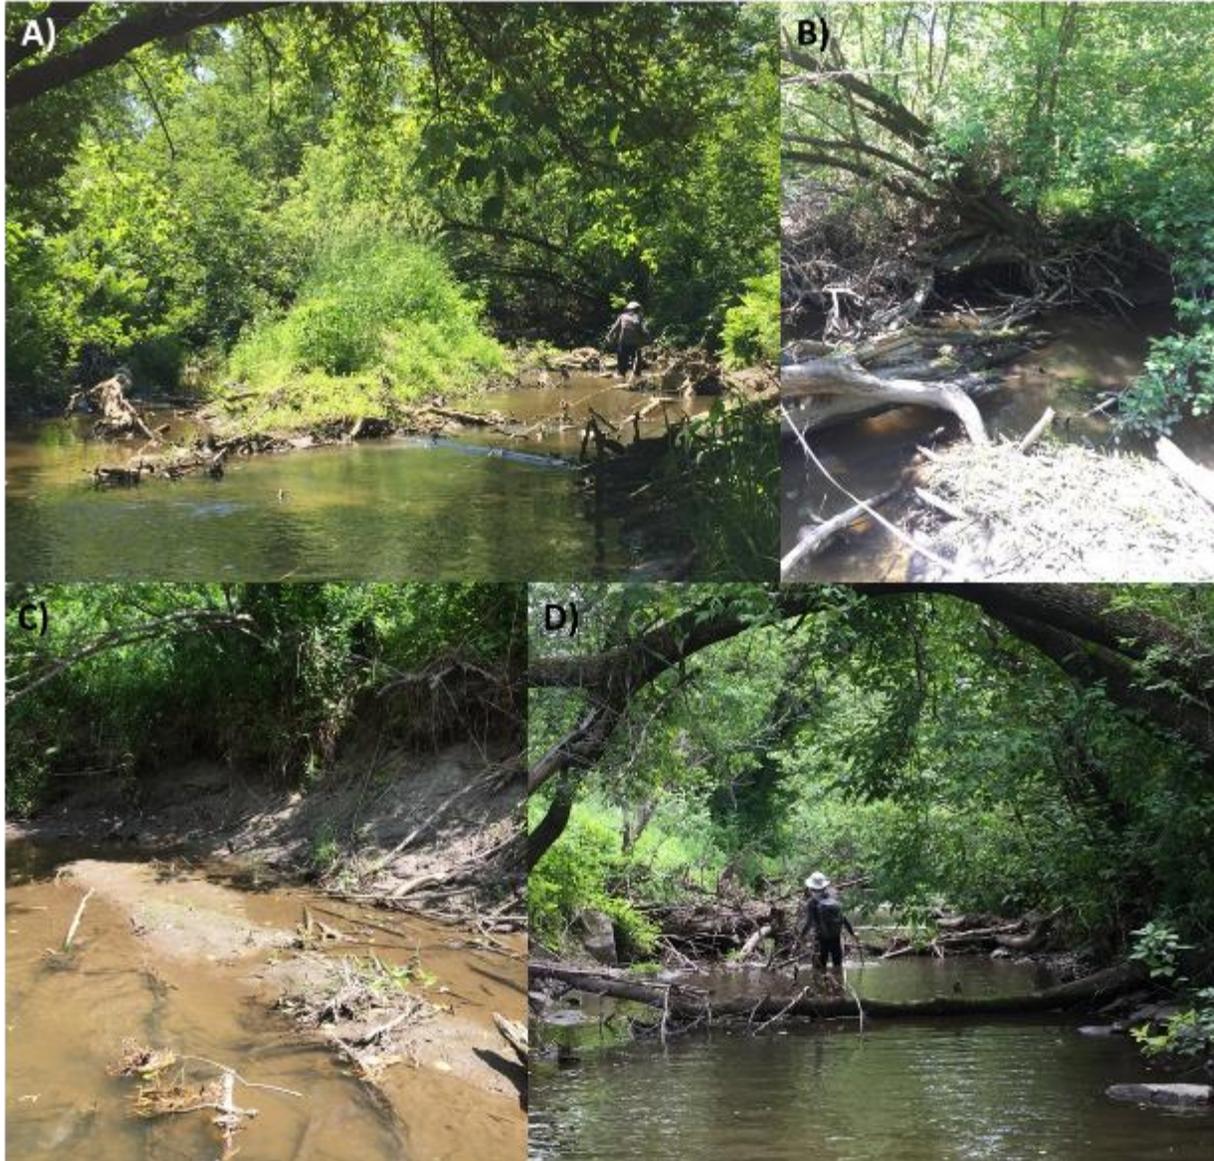
Figure 78: Field evidence of current channel migration for RM. A) vegetated mid channel bar, B) log jam, C) fluvial erosion along bank and D) channel spanning woody debris.

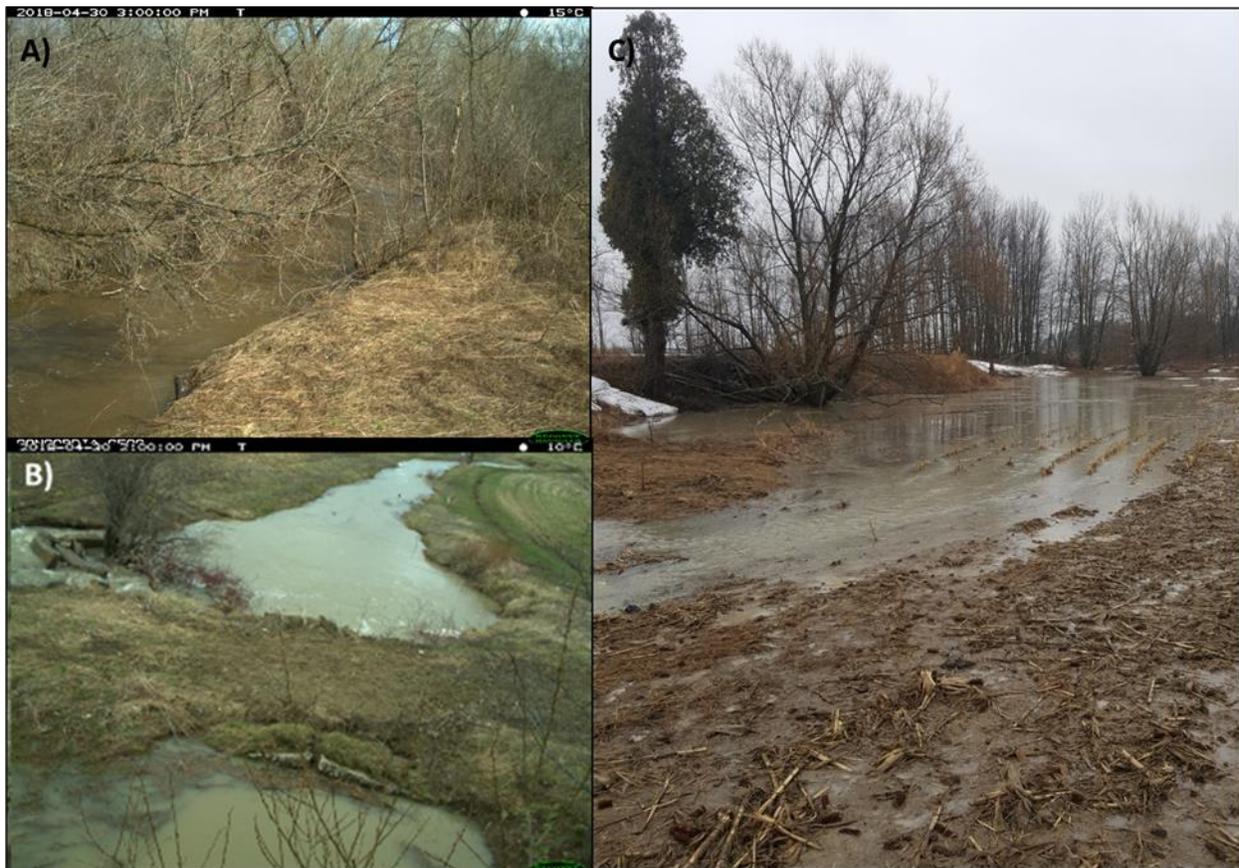
Figure 79: A) Photo from camera installed at RM facing the ancient meander showing peak fall discharge reaching just below bankfull; B) Photo of narrow culvert at PPauB forcing peak flows to flood surrounding land; C) Example of surface water flooding on agricultural land at PPauB during the spring floods of 2018.
